Manhole Inspection Summary

Manhole # S33Q__013MH

Insp Date: **3/14/08 9:54 AM**

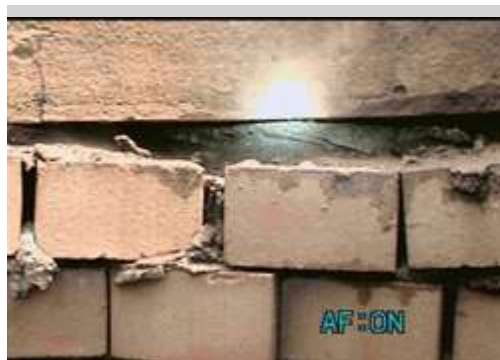
Defect 3

bench debris

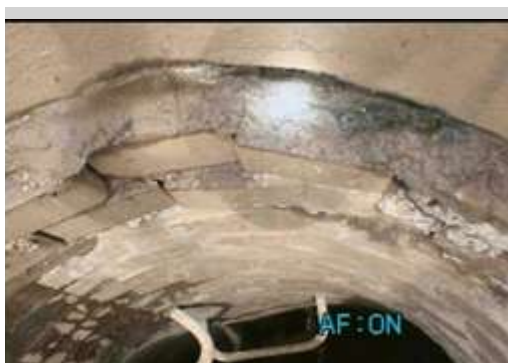
Defect 2

Frame Offset: **1** (in.) Condition: ☐ Sound ☒ **Cracked** ☐ Leaks

Condition: ☐ Sound ☐ Cracked ☐ Root Intrusion ☒ **Loose Brick** ☐ Deteriorated

Infiltration: ☐ None ☒ **Joint** ☐ Cracks ☐ Mortar ☐ Roots ☐ Wall

cracked frame, infiltration, chimney loose bricks, frame adj

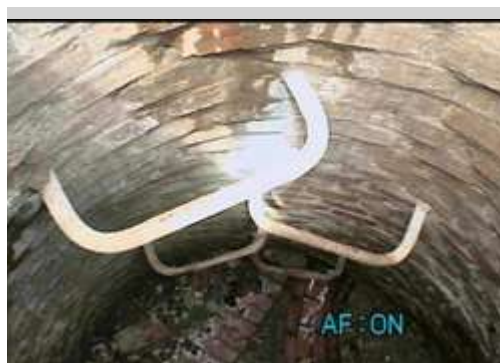
Defect 1

Infiltration: ☐ None ☒ **Joint** ☐ Cracks ☐ Mortar ☐ Roots ☐ Wall

Steps Count: **4** Missing: **0** ☒ **Corroded**

offset

signs of corbel infiltration, corroded steps
